## Integrated Geophysical Investigation Of Structural Failure Of A Building At Ido Local Government Secretariat Ibadan, Nigeria.

**Abstract:** The House of Chief Building at Ido Local Government Council Secretariat Ibadan, which was commissioned in April 2008, has developed several cracks on its walls and floors, making it uninhabitable. The integration of Very Low Frequency (VLF) Electromagnetic and Electrical Resistivity methods were used to establish the effect of foundation on the failure of the building. Eight VLF traverses were laid across the building and its immediate surrounding for profiling in the N-S direction from where thirteen station points were selected for Vertical Electrical Sounding (VES) using the Schlumberger configuration. Three subsurface layers were delineated; the topsoil, clayey layer and weathered basement with resistivity values ranging from 88–416 $\Omega$ m, 28–155 $\Omega$ m and 256–7635 $\Omega$ m respectively. The thicknesses of the top soil and the clayey layer ranged from 0.7–2.1m and 6.1–14.8m. Around the vicinity of the building, the resistivity of the weathered layer beneath the foundation was found to be low, ranging from 28–75 $\Omega$ m ty

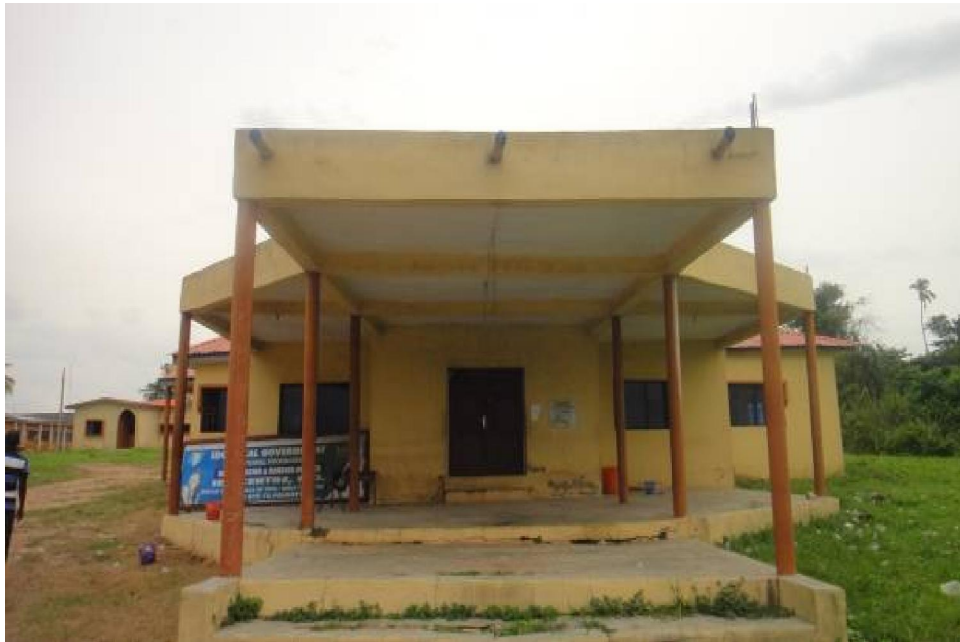
This study was carried out to find out the effect of the sub-surface materials on the structural failure observed on the House of Chief Building at Ido Local Government Secretariat. The building (fig. 1) which was commissioned in 2008 has since developed several cracks on its walls and floor (fig. 2-4) and has been vacated owing fear of sudden collapse. A notable horizontal crack (fig. 2) on part of the wall seemed to be an indication of partial sinking of the foundation

Figure 1: Grasses growing on the crack floors

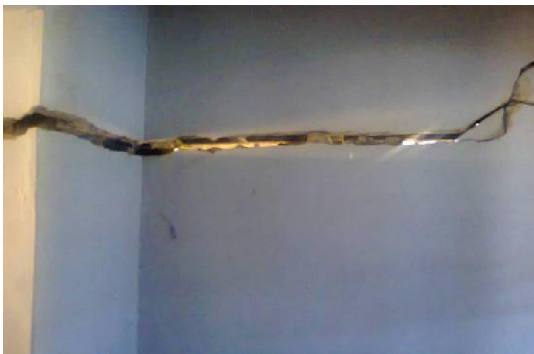
which could be due to insufficient load bearing capacity of the material underneath.

Figure 2: Sign of differential settlement

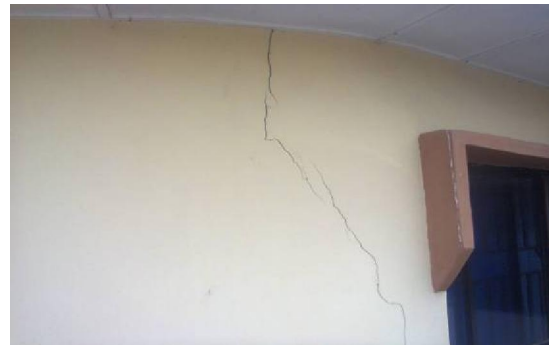
Figure 4: Cracks on the outside wall

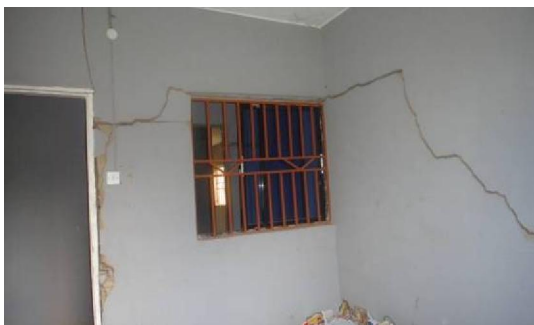
Figure 3: Cracks in one of the rooms

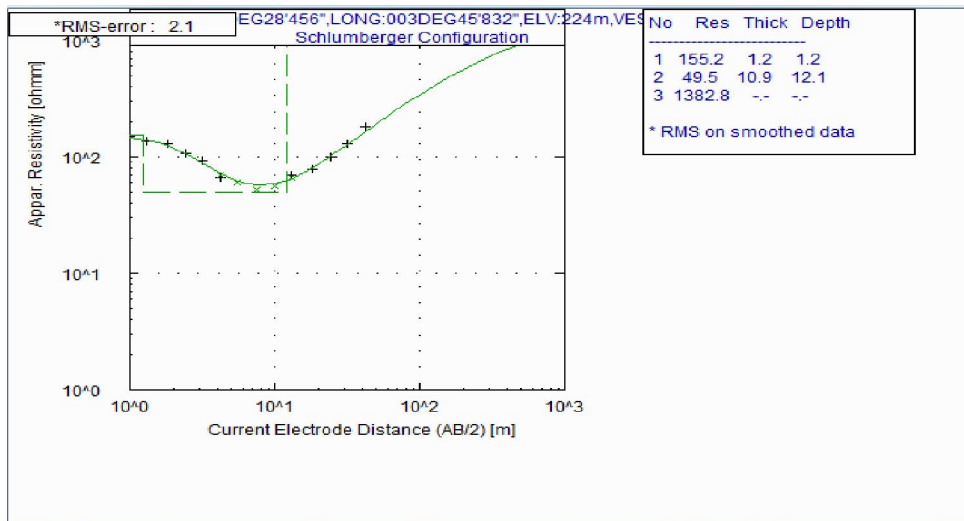
Figure 15. Sample vertical electrical sounding (VES 7) curves obtained

were confirmed by the results of electrical resistivity measurements since the VES points all revealed layers with considerably low resistivity values. In particular, VES 7 spot which contained a layer of least resistivity of 28.6  $\Omega$  m and the highest peak on the VLF graph.

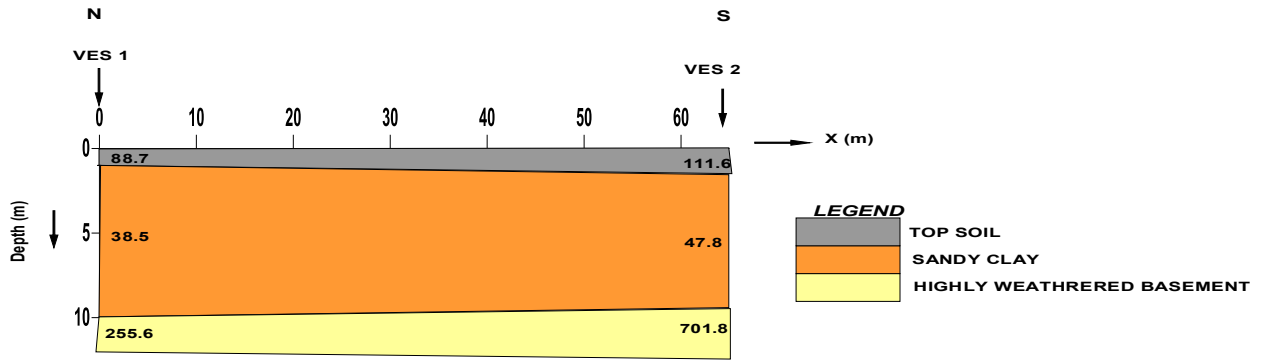
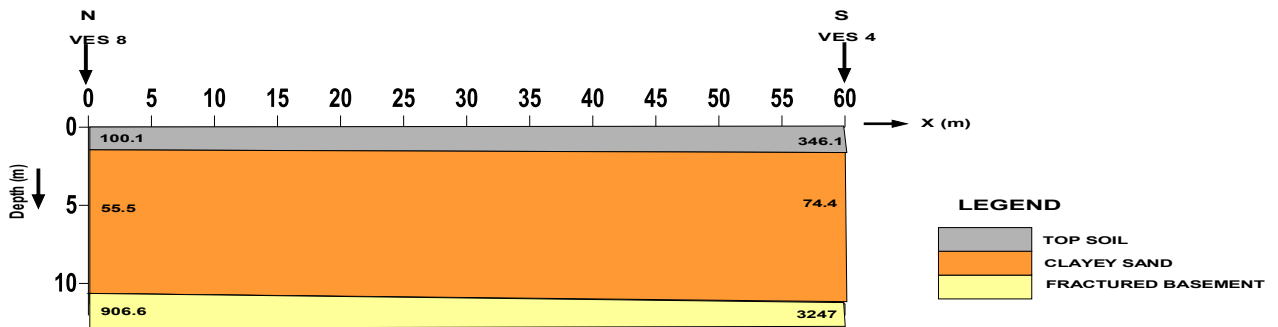
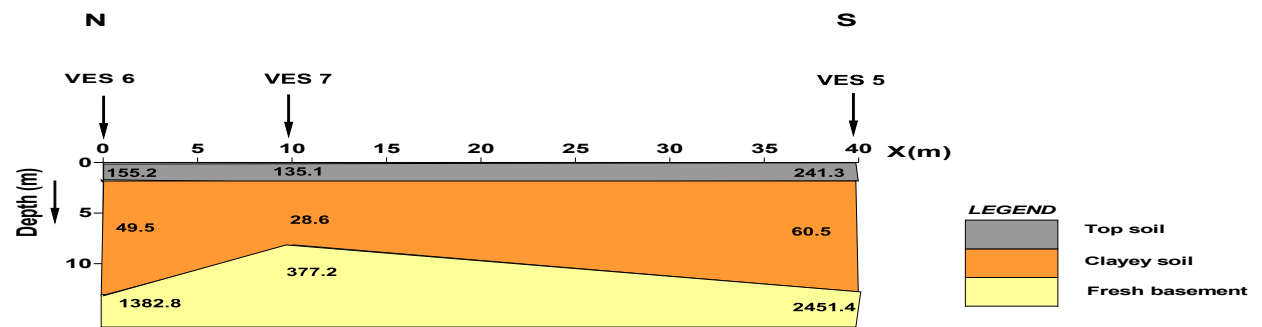
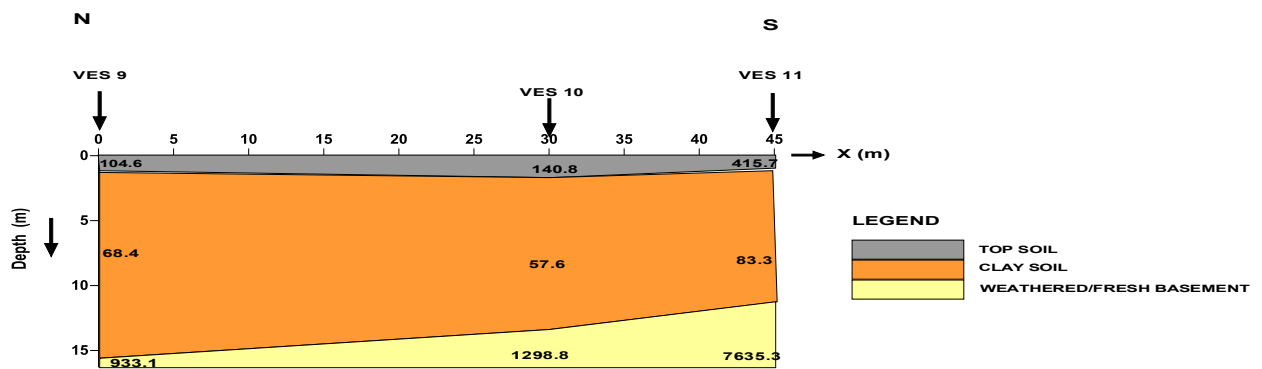
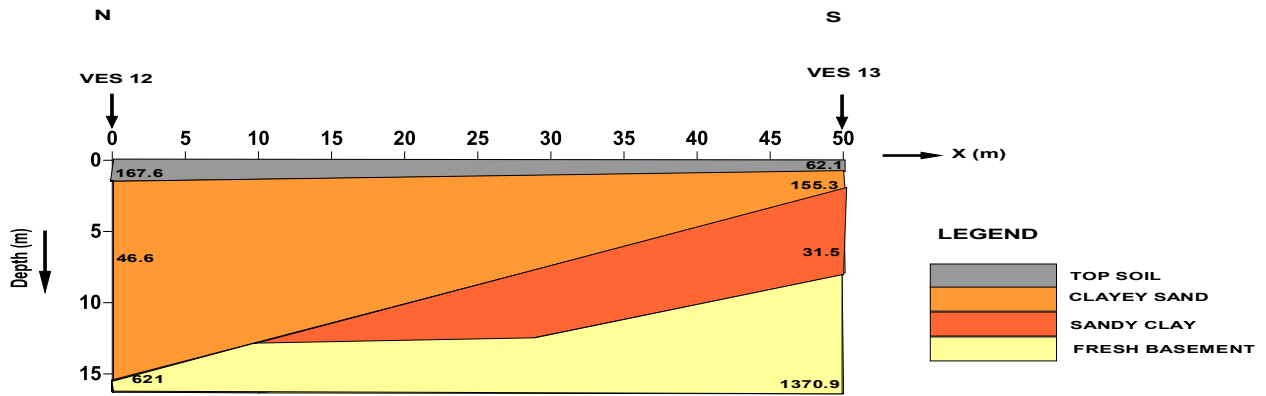
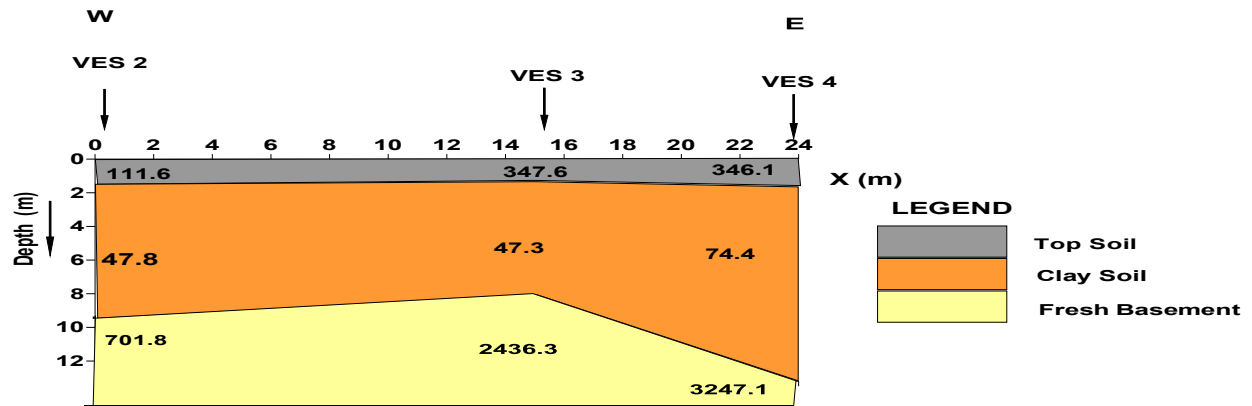
The goelectric sections (fig. 16-23) provide the one dimensional imaging of the subsurface layers beneath and in the vicinity of the distressed building to a maximum depth of about 15 m Topsoil Layer Resistivity Map.

The resistivity of the topsoil varied generally from 62 – 416 ohm-m while the thickness varied from 0.7 – 2.1m. Underneath the distressed building, the topsoil layer resistivity varied from 88.7 – 28028 ohm-m. Zones within the topsoil where the resistivity values were less than 300 ohm-m are considered

geotechnically incompetent to carry large engineering structures (Adesida and Omosuyi, 2005) At the depth of 5 m, resistivity varied from 28.6 to 155  $\Omega$ m around the distressed building. This is typical of clayey materials. Therefore at this depth, the Eastern part of the study area in which the distressed building is located is geotechnically incompetent to bear construction load. This material extended further to a depth of 10 m.
