Gully Erosion And Landslides In Southeastern Nigeria: Causes, Consequences And Control Measures.Boniface C.E. Egboka^a and Akudo Ernest Orji^b^a Department of Geological Sciences, Nnamdi Azikiwe University, P.M.B. 5025, Awka, Nigeria^b Department of Energy and Petroleum Studies, Novena University, Ogume, P.M.B. 2, Kwale Nigeria*Corresponding author: Tel., +2348035371235; Email- ernestakudo@gmail.com

Abstract: In southeastern Nigeria, soil and gully erosion and landslides are responsible for the widespread destructions of human, animal and plant lives, domestic, industrial and commercial property, transportation and communication systems, degradation of arable lands, contamination of surface and groundwater supplies, isolation of settlements and migration of communities. This account presents some of the results of research and studies of gully erosion and landslides carried out over the years in parts of southeastern States of Abia, Anambra, Enugu, Ebonyi and Imo States. Gully erosion is attributed to natural and anthropogenic causes, with the latter being most prevalent. Gully initiation is the result of localized erosion by surface runoff and soil eluviation associated with rain

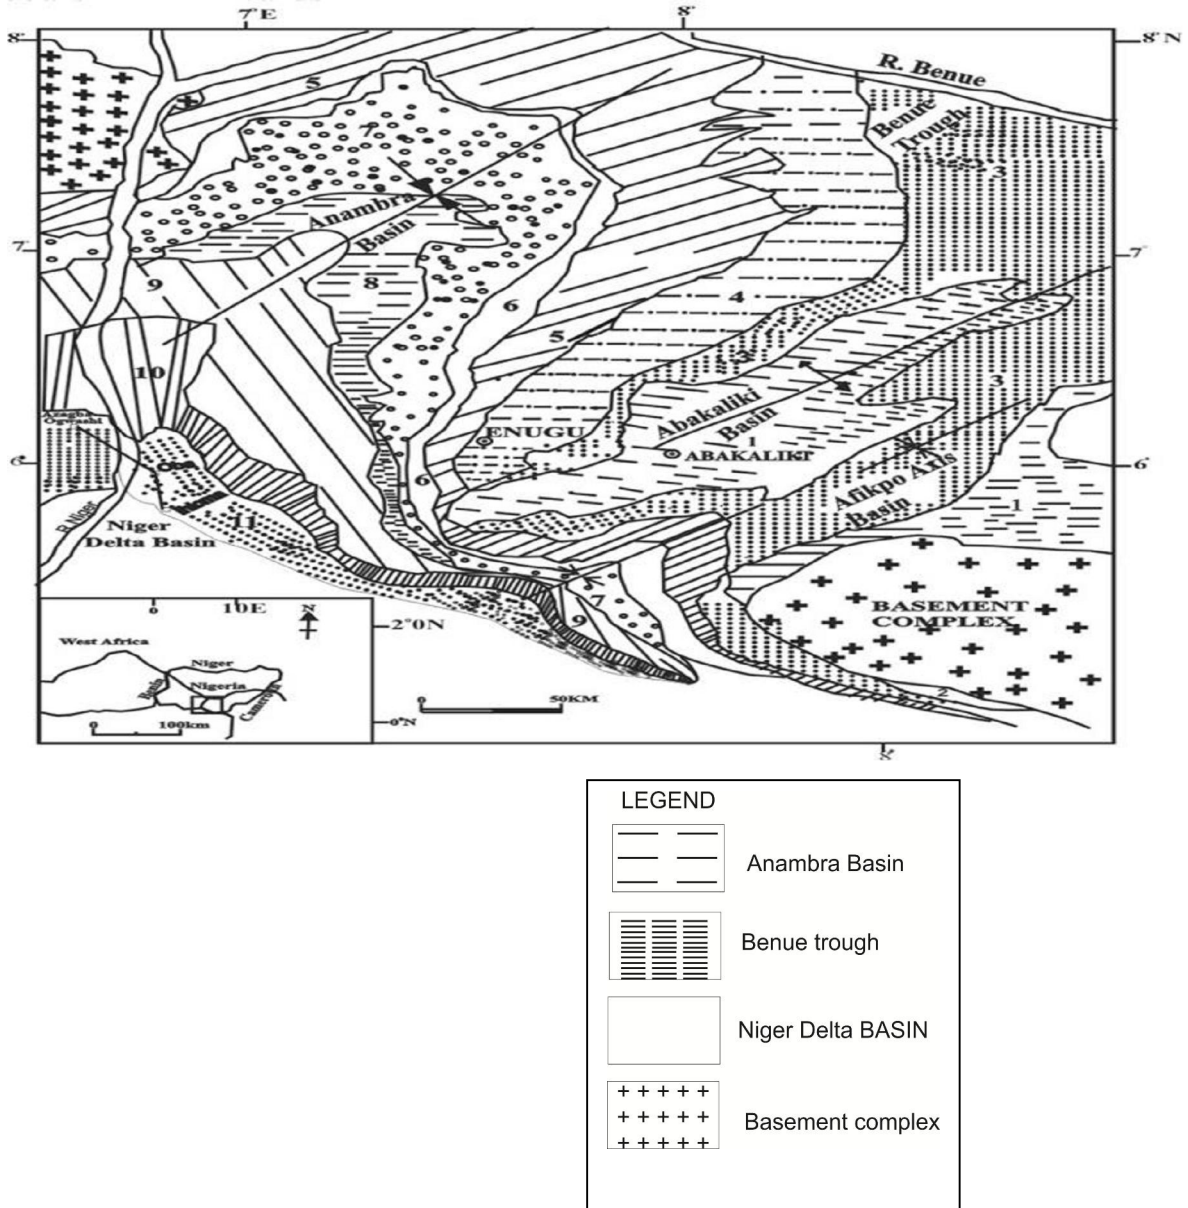
Figure 2: Geologic map of south-eastern Nigeria showing the study area (modified after Chiaghanam et al., 2013)

in the eastern area, the Imo and Cross Rivers together with their tributaries flow southwards and discharge their waters into the Atlantic Ocean. The tectonic movements for the formation of the Anambra Basin and the other areas were reactivated by further plate activity in lower Tertiary soon after the intermittent Upper Cretaceous rifting (Ogala, et al., 2009). The separation of the African and South American plates left the Benue Trough as an Aulacogen. Geologic formations such as hills that elongate in the north east to south westernly directions include Missions hill and Abakaliki hill (Fig. 2). The hills are generally of

The Geology of the area is a major factor in gully erosion causation and massive landslides that occur in several communities. The sandy members of the Ajalli Sandstone, Ameki Formation and Nanka Sands are very prevalent to denudation where they become exposed as sandy outcrops. Sometimes these sandy Formations have overlying and underlying shaley members that may bind the sandy units together. These Geologic Formations contain saturated groundwater members or aquifers whose pore water

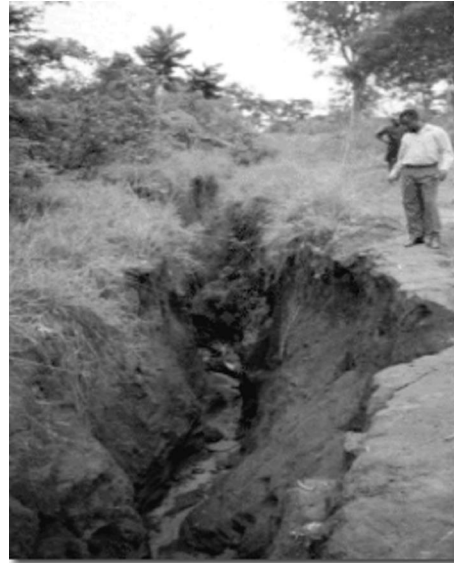
Figure 3. Gully erosion site in Amaokwe, Figure 4. A Gully site in Umuchiana, Aguata, Anambra State, Abia State.

a. **Displacement of Large Population of People and Refugees:** The entire Communities in Amaokwe (see some erosion sites in Figure 3 & 5), Abia State University, Uturu, Ogudasa and Oruruala were completely displaced due to the expansion of gully sites. The Amuzukwu community in Umuahia North L.G.A of Abia State suffered the same fate and is now hapless refugees.

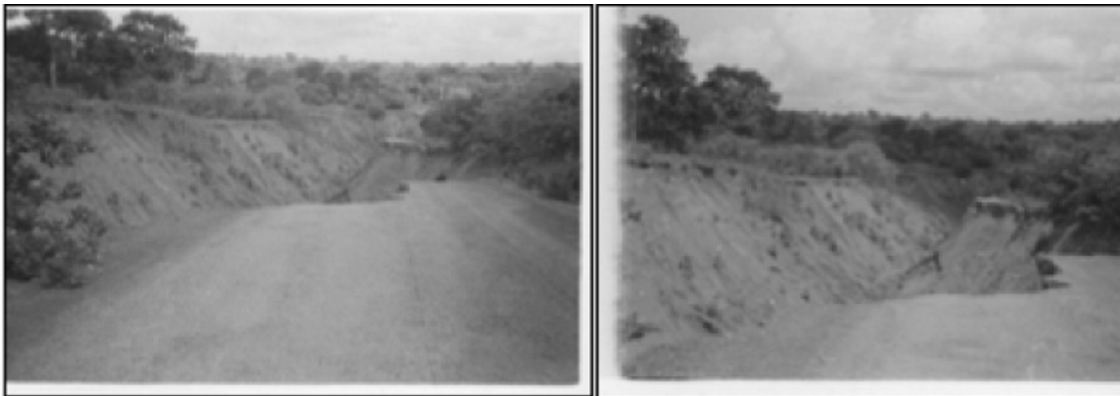
Figure 5. Eroded sites in Amaokwe Community, Abia State

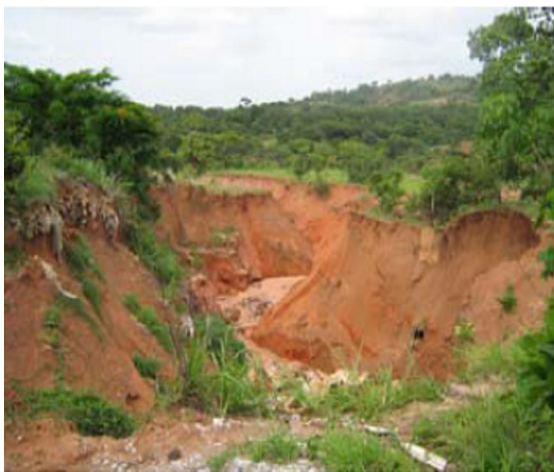
Figure 6. Gully Site at Nach-Agbalaenyi, Enugu State

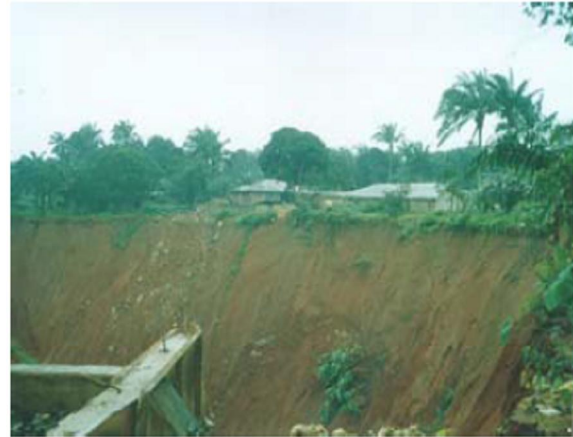
Figure 7. A Gully Site in Umuchu, Anambra State

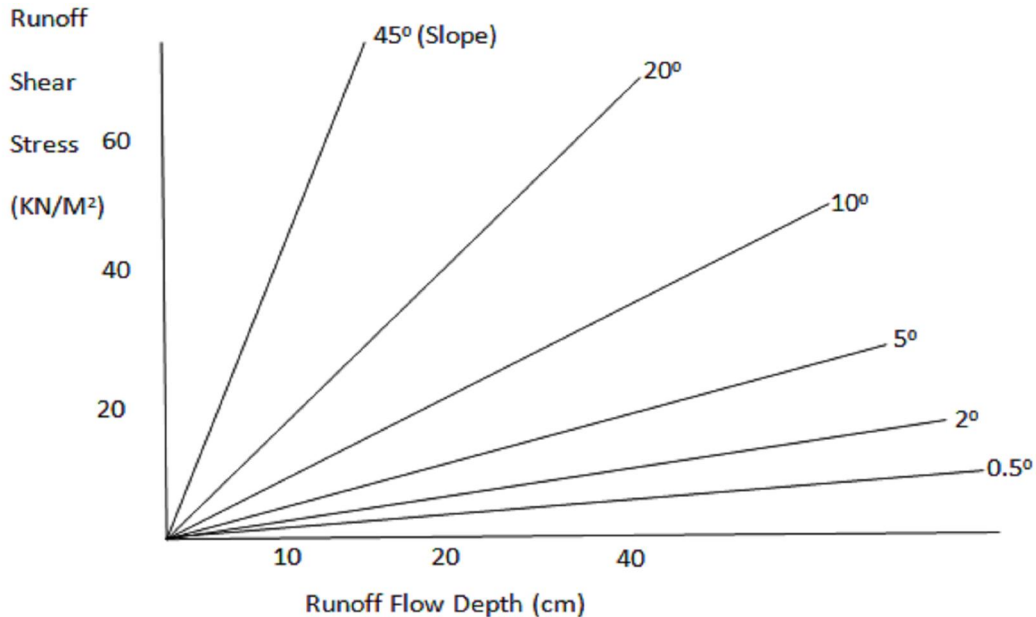
Figure 8. Plot of Runoff Shear Stress Flow Depth for Various Slope Angles of Ground Surface (after Nwankwo et al., 2015)

Findings from previous research (Nwankwo et al., 2015) revealed that soil and gully erosion would be expected to occur when the shear stress of runoff exceeds the soil shear strength. Table 3 and Figure 8 show that the shear strength of top soils is higher than the shear stress of runoff for normal ground surface slope angles of less than 5⁰ and few depths that occur naturally (much less than 10cm). The red earth (RE)

and, in particular, the bottom parent material (FS) have a shear strength values that are less than or marginally comparable to runoff shear stress, more so when flow is not concentrated. It is thus clear that once the top soil is removed and/or runoff is concentrated (ie increase in flow depth), erosion is inevitable. One obvious way by which the top soil is
