## Integrated Geophysical Investigation Of Structural Failure Of A Building At Ido Local Government Secretariat Ibadan, Nigeria.

**Abstract:** The House of Chief Building at Ido Local Government Council Secretariat Ibadan, which was commissioned in April 2008, has developed several cracks on its walls and floors, making it uninhabitable. The integration of Very Low Frequency (VLF) Electromagnetic and Electrical Resistivity methods were used to establish the effect of foundation on the failure of the building. Eight VLF traverses were laid across the building and its immediate surrounding for profiling in the N-S direction from where thirteen station points were selected for Vertical Electrical Sounding (VES) using the Schlumberger configuration. Three subsurface layers were delineated; the topsoil, clayey layer and weathered basement with resistivity values ranging from 88–416 $\Omega$ m, 28–155 $\Omega$ m and 256–7635 $\Omega$ m respectively. The thicknesses of the top soil and the clayey layer ranged from 0.7–2.1m and 6.1–14.8m. Around the vicinity of the building, the resistivity of the weathered layer beneath the foundation was found to be low, ranging from 28–75 $\Omega$ m ty

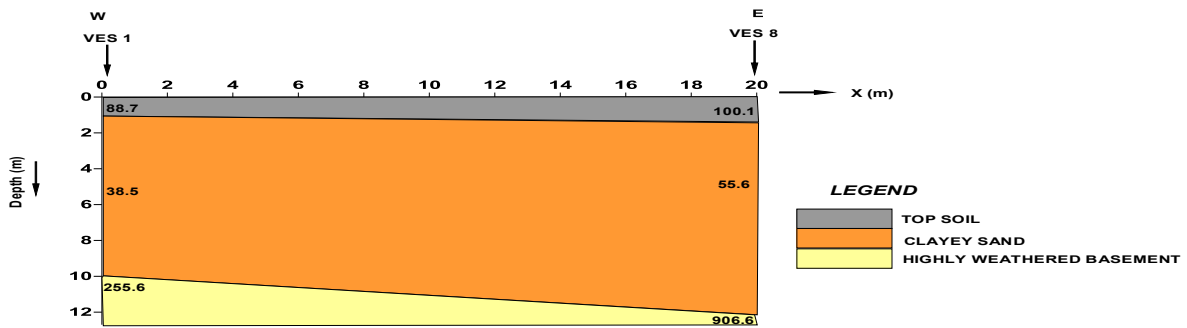
Figure 22: Geoelectric Section across Traverse 1 and 5

The interpretation of the geoelectric sections revealed the following as the possible cause of the failure:

1. Clayey nature of the soil on which the building was constructed. Clay, though highly porous, is less permeable owing to poor connectivity of its pores, retains water without releasing it thus makes it swell up and collapse at the exertion of pressure thereby leading to foundation failure.

2. Presence of near surface linear features such as faults, fracture and joints etc. in the subsoil beneath the building foundation which led to structurally weak zones that enhanced ground water accumulation and hence foundation failure.

3. Closeness of the weathered layer to the surface implies that the building foundation is resting within the water table.

1. It is recommended that the building should be marked for demolition to avert self destruction which may lead to loss of lives and property.

2. For reconstruction, the foundation must be reinforced with piles up to about 10m deep and a German-flooring is highly recommended. This will block seepage of water into the building floor.
